Piper Aircraft, Inc.
2926 Piper Drive
Vero Beach, FL, U.S.A. 32960

SERVICE NO. 1372A BULLETIN

Date: October 10, 2024

MAIN WING SPAR INSPECTION

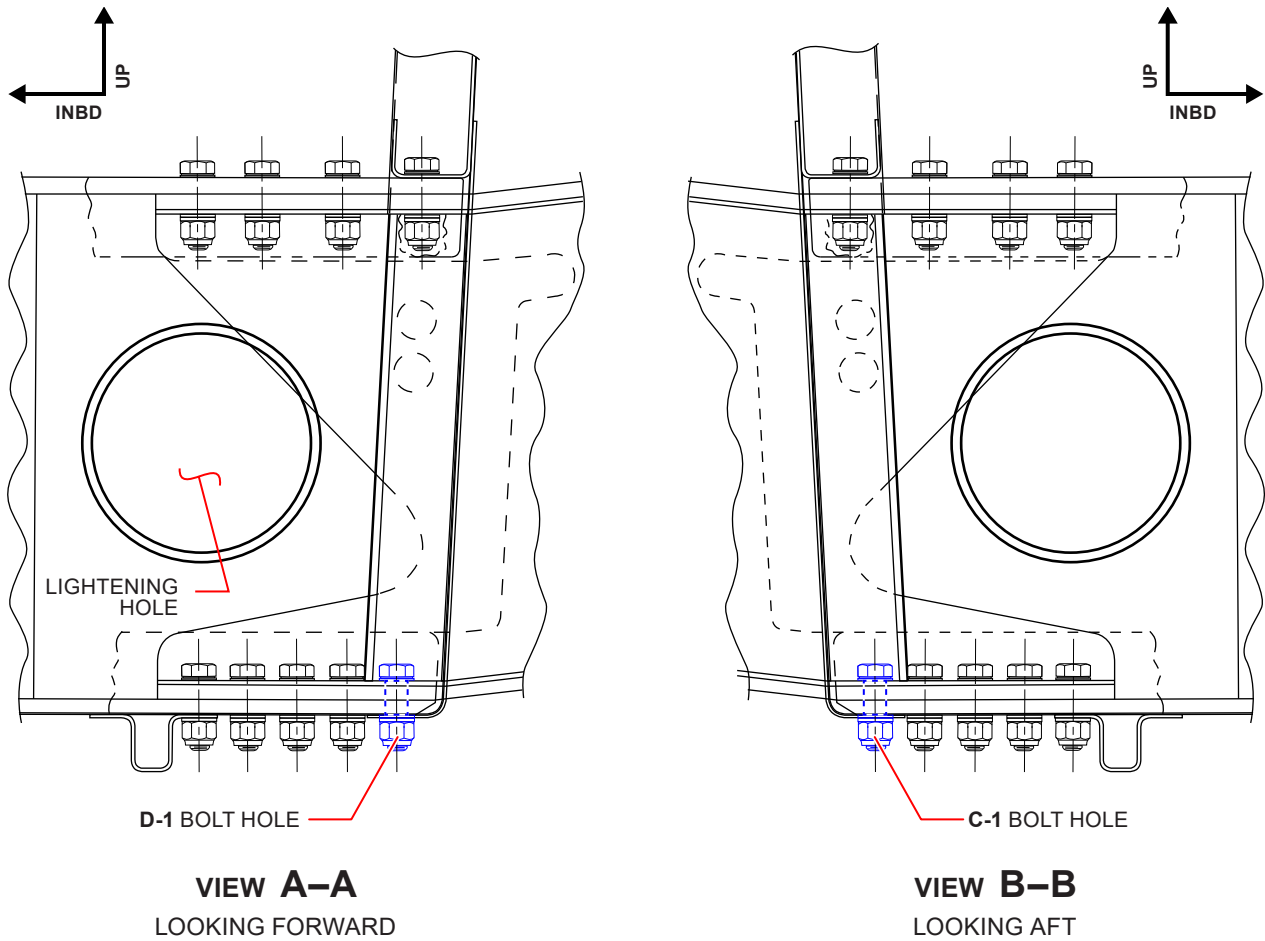
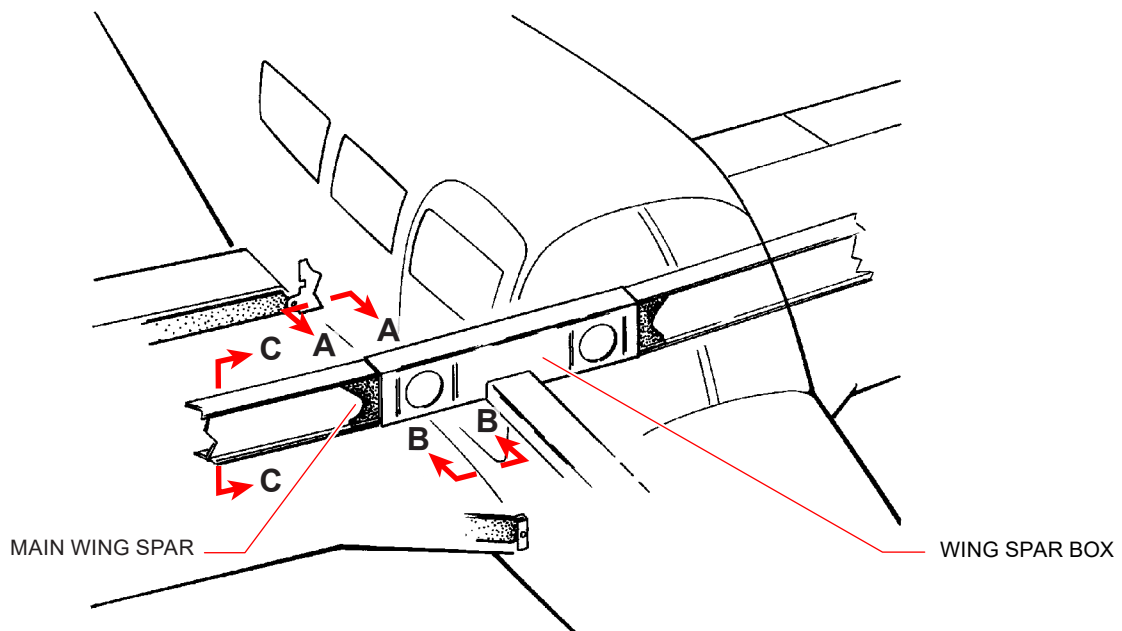
Figure 1 (Sheet 1 of 2)
Typical Main Wing Spar Attach Bolts and Spar Cross Section (Right Wing Shown)

SAFETY INTENT: Depending on the severity of usage, some of the affected aircraft may have fatigue fractures at the lower outboard-most main wing spar attachment bolt holes (designated as C-1 and D-1 as shown in Figure 1 on page 16).

WARNING: Do not drive bolts into or out of the main spar attaching bolt holes (see Views A-A and B-B). Be careful to avoid damaging the bolt holes while removing and replacing the bolts. Refer to "Care for Bolts and Bolt Holes" in this service bulletin.
