Piper Aircraft, Inc.
2926 Piper Drive
Vero Beach, FL, U.S.A. 32960

SERVICE NO. 1372A BULLETIN

Date: October 10, 2024

MAIN WING SPAR INSPECTION

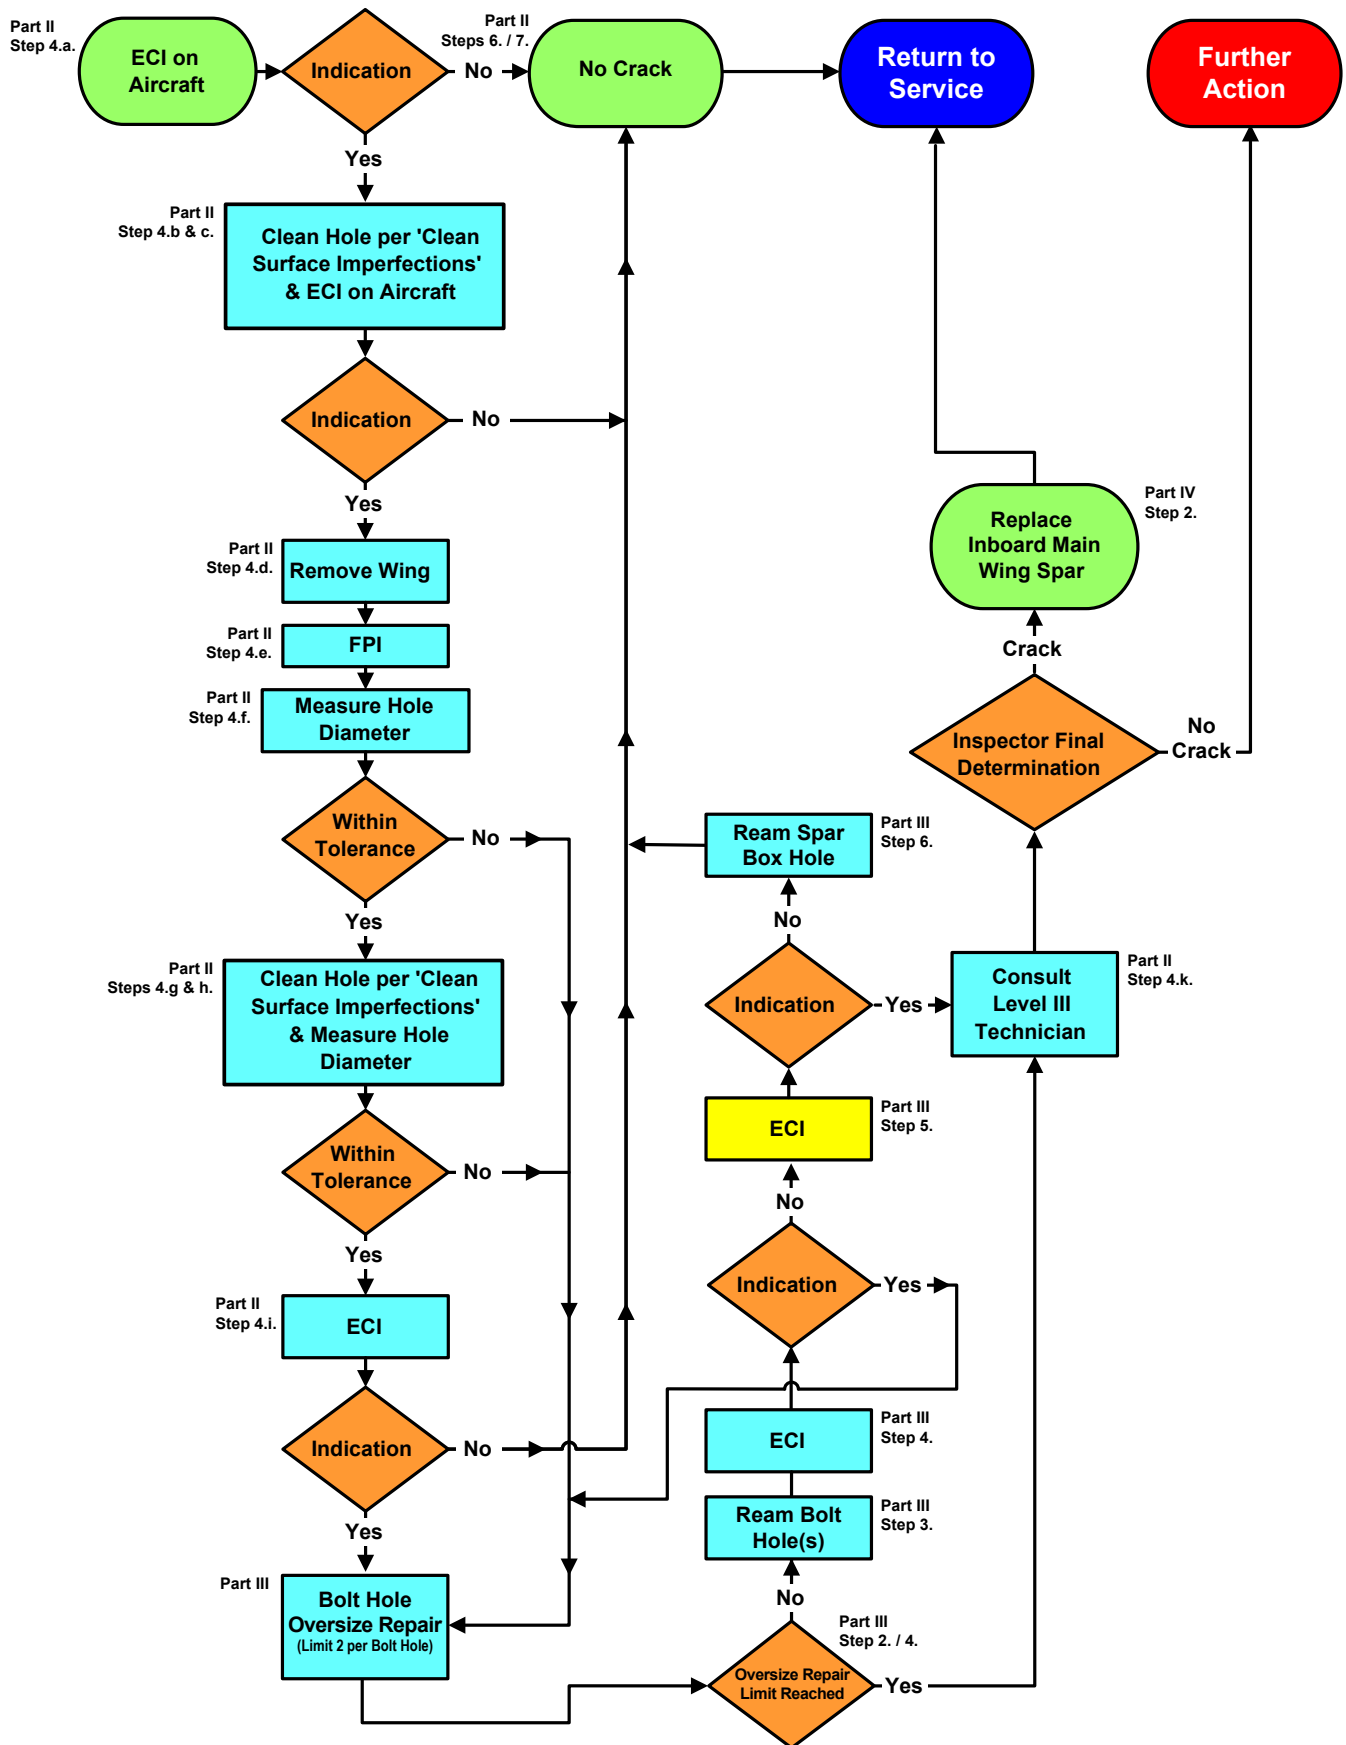
Figure 1 (Sheet 2 of 2)

SAFETY INTENT: Depending on the severity of usage, some of the affected aircraft may have fatigue fractures at the lower outboard-most main wing spar attachment bolt holes (designated as C-1 and D-1 as shown in Figure 1 on page 16).

3. Carefully remove the two (2) spar attach bolts using the guidance described in "Care for Bolts and Bolt Holes" page 15. Discard the bolts and nuts. Retain or replace the washers on condition.
4. RC – Inspect the inner surface of each bolt hole in the lower spar cap. Figure 1 provides cross sections of the spar, and identifies the bolt hole inspection areas.

Typical Main Wing Spar Attach Bolts and Spar Cross Section (Right Wing Shown)

1. Review the guidance in "Care for Bolts and Bolt Holes" on page 15 for methods on safe spar attach bolt removal. Do not proceed until the fuselage and wings are properly supported as described in this section.
2. Locate the two (2) outermost spar attach bolts, as shown in Figure 1, installed on the lower cap of the left and right spar, on the forward and aft sides of the spar web.

NOTE: When radius washers are properly installed, the radius feature of the washer will be oriented to match the radius of the adjacent structure, as shown in Figure 1, Detail D.
